# Stainless Steel Restoration Works

## Photographic Completion Report

| <b>Project</b> | Pool Area Stainless Steel Restoration |
| <b>Location</b> | 19 Hickson Road, Dawes Point NSW |

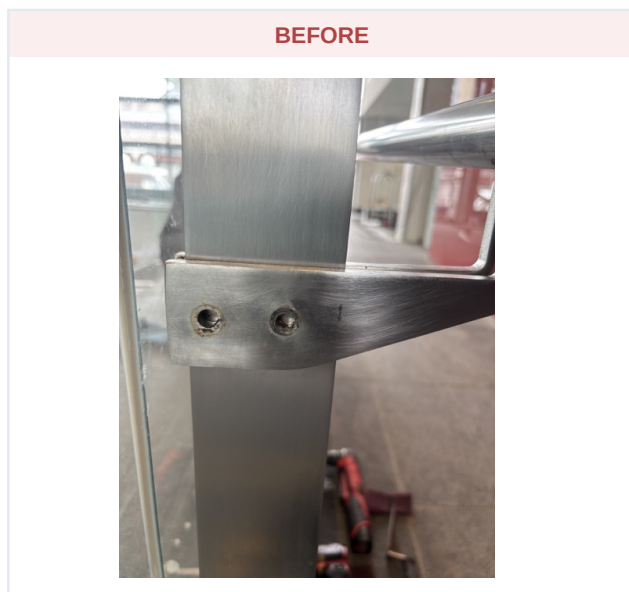
### Pair A — Handrail bracket / post connection

Handrail bracket / post connection - before restoration

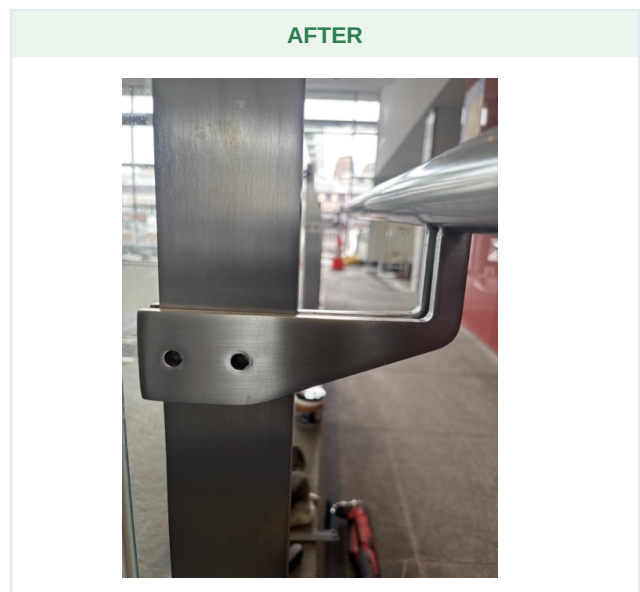
Handrail bracket / post connection - after restoration

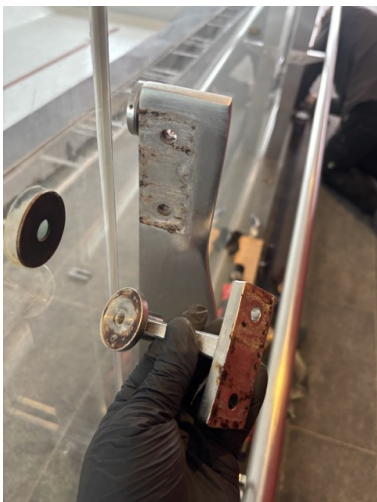
## Pair B — Stainless base plate

Stainless base plate - before restoration

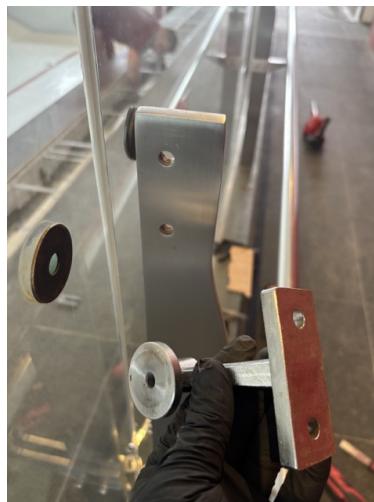
Stainless base plate - after restoration

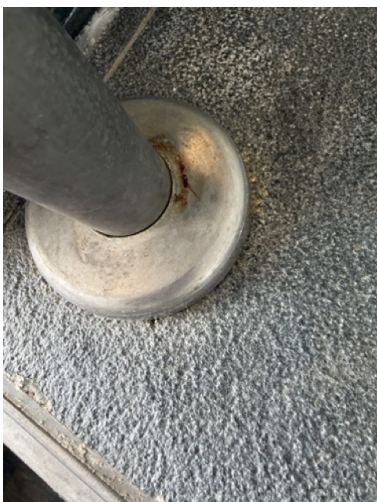
## Pair C — Stainless post / handrail section

Stainless post / handrail section - before restoration

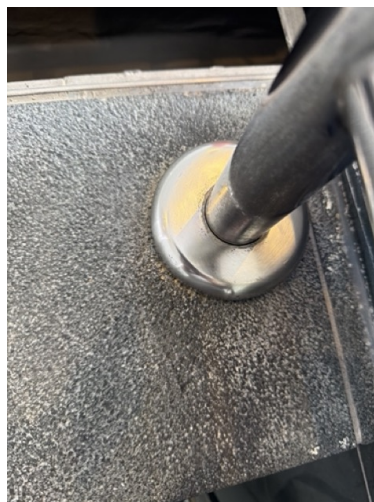
Stainless post / handrail section - after restoration

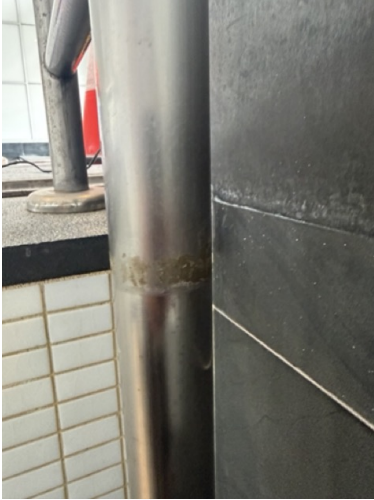
### Pair D — Bracket / glass fitting assembly

Bracket / glass fitting assembly - before restoration

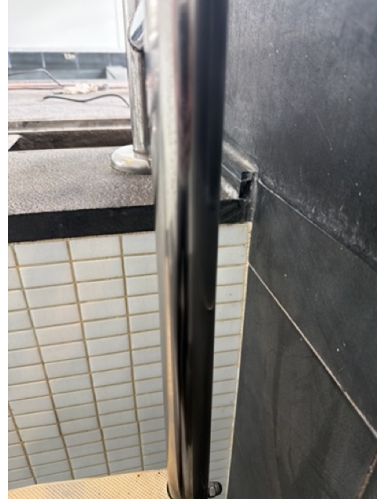
Bracket / glass fitting assembly - after restoration

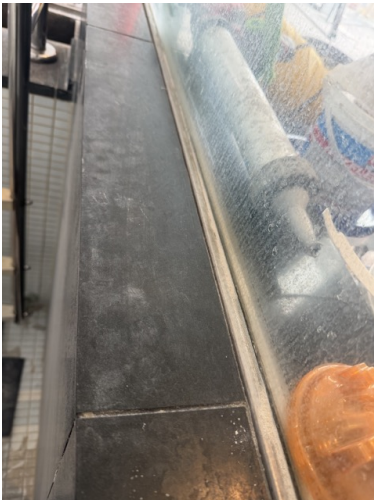
### Pair E — Stainless trim / channel adjacent to glazing

Stainless trim / channel adjacent to glazing - before restoration

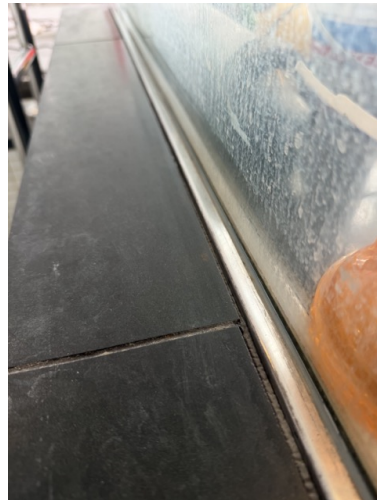
Stainless trim / channel adjacent to glazing - after restoration

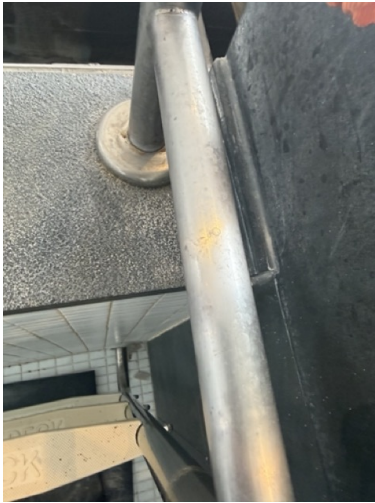
## Pair F — Handrail surface

Handrail surface - before restoration

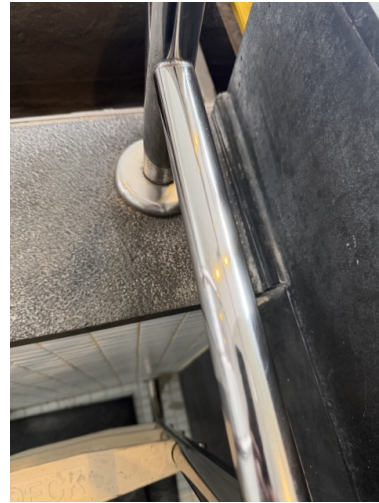
Handrail surface - after restoration

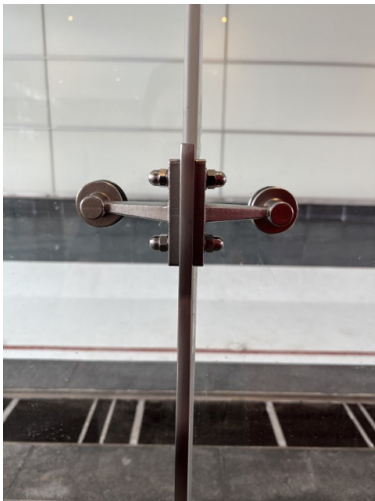
Additional completed stainless fitting detail

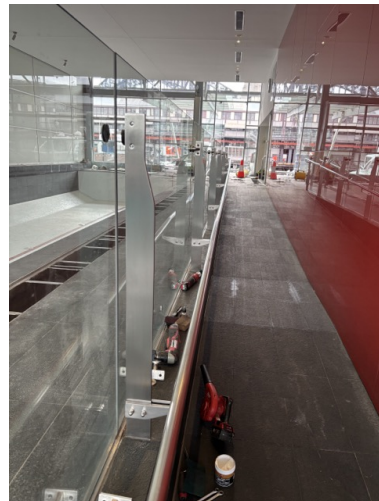
Additional completed balustrade / handrail detail
